Dam and Foundation Responses to the 2016 M_w 7.8 Kaikōura Earthquake in New Zealand

Andrew Balme, Dan Forster, Tim Logan

Dam Safety Intelligence.

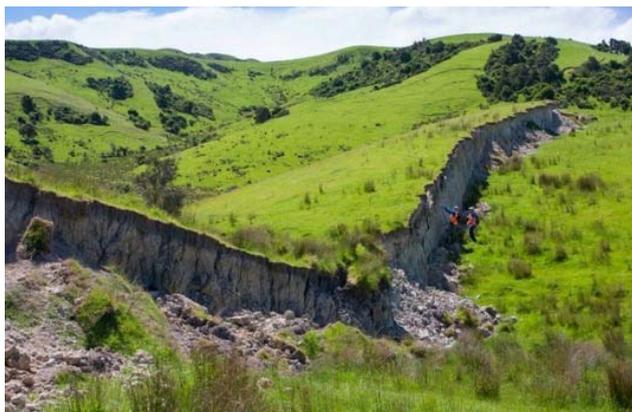
Figure 2: Vertical surface displacement along Leader Fault. Photo courtesy of Kate Pedley.

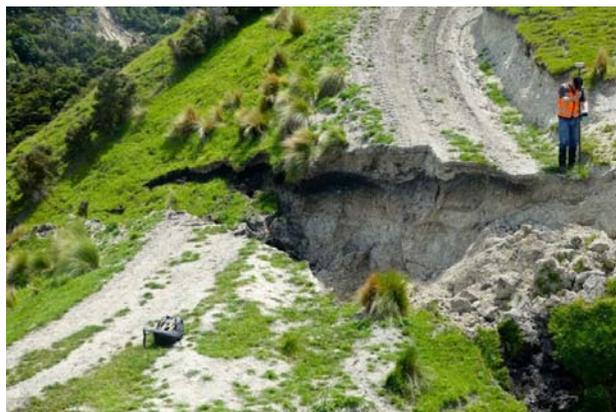
Figure 3: Vertical and horizontal surface displacement along Kekerengu Fault. Photo courtesy of Tim Little.

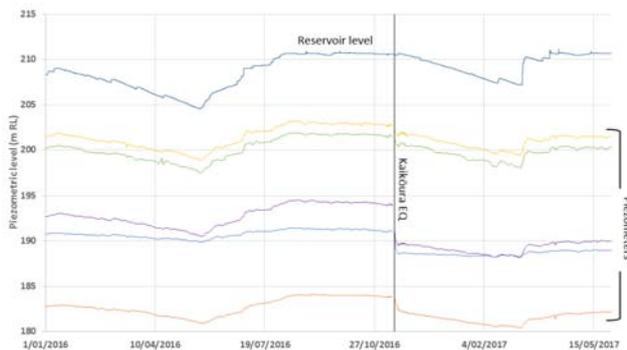
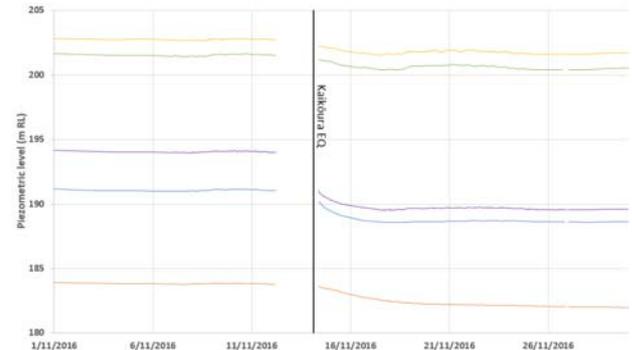
Instrumentation installed in dams located across New Zealand show varying responses to the Kaikōura earthquake. The largest detected piezometric response was at the Waitakere Dam, located 655 km north of the Kaikōura earthquake epicentre where piezometric pressure drops of up to 4 m were recorded. Piezometric data is plotted in Figures 7 (a) and (b); due to an unrelated communications error, data in the days leading up to the earthquake was not available. Changes in foundation pressures occurred predominantly at concrete dams with rock foundations; however, some responses were also observed at earth dam foundations, which included reduction in earth dam core pressures, and both decreases and increases in abutment pressures. In the 6 months since the earthquake some of the piezometric readings have begun returning to their usual pre-earthquake levels, while others appear to have equilibrated at new normal levels.

Figure 7a: Response at Waitakere Dam foundation piezometers, large time scale (January 2016 - May 2017) with reservoir level. Vertical line represents Kaikōura earthquake.

Figure 7b: Response at Waitakere Dam foundation piezometers, small time scale (November 2016). Vertical line represents Kaikōura earthquake.

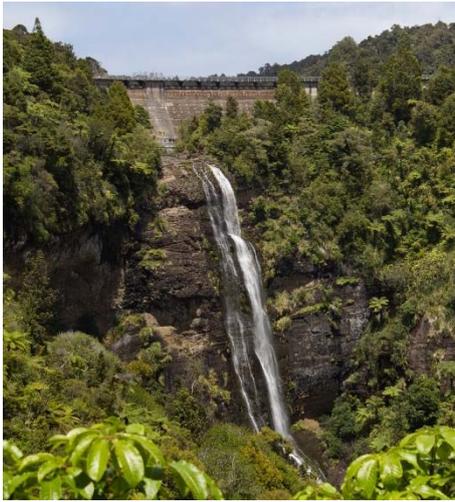
Figure 8: Waitakere Dam. Image courtesy of New Zealand Tramper.

As discussed previously in “Comparison of ground motions and discussion of influencing factors”, surface topography has been shown to have a significant impact on recorded ground motions with reported topographic amplification ratios of up to 20. The Waitakere Dam is a curved concrete gravity dam with a maximum height of 26 m. The dam is situated on top of a ~110 m near vertical cliff (see Figure 8), and therefore it is plausible that the ground motions experienced by the dam and its foundation were greater than those in the valley below, and potentially much greater than the range of ground motions recorded in the surrounding region. The foundation response recorded, up to a 4 m drop in piezometric pressures, are some of the largest recorded at any dam included in this review despite the relatively large distance, ~650 km, from the Kaikōura earthquake epicentre. Our interpretation of the drop in foundation pressures is that the shaking of the foundation has improved drainage either through the exposed cliff face, or deeper into the foundation. Whilst this behaviour is not yet fully understood, this response is not considered to indicate adverse performance of the dam. Stable pressures relative to lake level since the initial response provides assurance that foundation conditions have not changed any further.

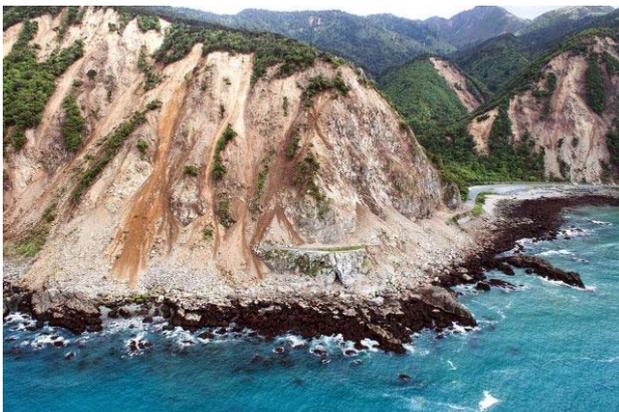
Figure 9: Coastal landslides generated during Kaikōura earthquake. Photo courtesy of Sgt. Sam Shepard.

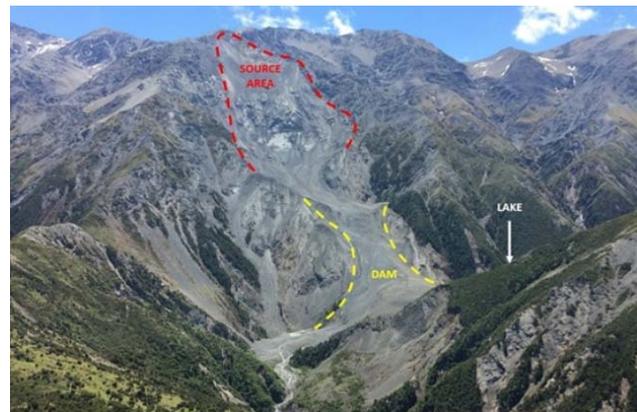
At least 190 landslide dams generated by the Kaikōura earthquake have been identified (Kaiser et al 2017), predominantly in remote mountainous areas; however, many of these present significant failure consequences. The Hapuku landslide dam, refer Figure 10, formed when 10–14 million cubic metres of rock travelled 2.7 km to the valley floor (GeoNet 2017b) forming an approximately 150 m high landslide dam. Downstream populations were evacuated shortly after some of the larger landslide dams were identified due to the risk of failure. One in particular on the Clarence River, the eighth longest river in New Zealand, breached 16 hours after it was formed releasing an estimated 1,000–2,000 m³/s in a 15 m surge of water and debris. Environment Canterbury, the regional council, set up monitoring of a small number of these dams with the highest risks of failure. Over half (approximately 56%) of naturally created dams fail within a month after formation, around a third fail over time due to sustained overtopping and erosion or slope instability caused by seepage through the dam, and the rest became semi-permanent or permanent features (Costa and Schuster 1988). Perhaps the most well-known landslide dam in New Zealand is the landslide that formed Lake Waikaremoana around 2,200 years ago (Offer 1997), which has since been developed for hydro generation; however, this was of a much larger scale compared to those formed during the Kaikōura earthquake.

Figure 10: Hapuku landslide dam formed during the Kaikōura earthquake when 10-14 million m³ of material shifted up to 2.7 km. Image courtesy of GNS Science.
