Dam and Foundation Responses to the 2016 M_w 7.8 Kaikōura Earthquake in New Zealand

Andrew Balme, Dan Forster, Tim Logan

Dam Safety Intelligence.

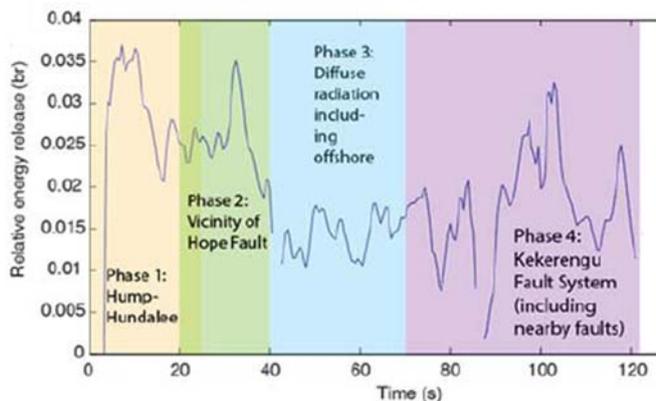
Preliminary analysis (Kaiser et al 2017) indicates at least four stages of rupture were identified, with three distinct northeastward-propagating phases of energy release as illustrated in Figure 4.

Figure 4: Four phases of fault rupture and three peaks in energy release. Reproduced from Kaiser et al 2017.

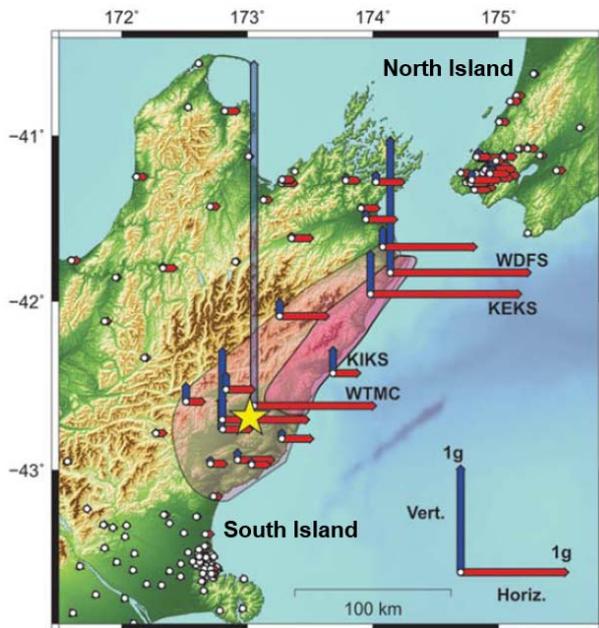
Figure 5: Peak ground accelerations (PGAs) measured at GeoNet monitoring stations during the Kaikōura earthquake. Epicentre shown as yellow star. Note PGAs at top of South Island and at bottom of north island are much larger than those at locations south of the epicentre. Extremely large vertical PGA near epicentre (transparent blue) under investigation to confirm if real. Pink shaded areas represent extent of mapped landslides with majority in the darker shaded area. Original image reproduced from Kaiser et al 2017.

The northwards propagation of fault ruptures and the multiple phases of energy release are reflected in the distribution of ground motions across the country. Horizontal and vertical PGAs greater than 1 g were recorded near the epicentre, and also around 130 km northeast near the top end of the fault rupture where vertical and horizontal PGAs were ~1.25 g. With the exception of an extremely high vertical PGA of over 3 g recorded near the epicentre, which is under investigation to its validity, these were the highest PGAs recorded. Figure 5 illustrates the PGA distribution across the top of the South Island and bottom of the North Island. There are clear similarities between the PGA distributions and the current understanding of the propagation of fault ruptures and phases of energy release summarised in Section “Fault ruptures and propagation”.

Tens of thousands of landslides were generated by the Kaikōura earthquake predominantly across an area of around 3,500 km², but some as far as 10,000 km² (Kaiser et al 2017). This is illustrated by the pink shaded areas on the previously shown Figure 5. The vast area in which landslides have been identified is a reflection of the topography and the complex seismic event and the numerous separate fault ruptures. Not surprisingly, the largest of the landslides occurred close to surface fault ruptures. Significant landslides along the east coast (refer Figure 9), up to 500,000 m³, blocked New Zealand's main arterial State Highway 1 as well the Main Trunk Rail Line; both remain closed with repairs expected to be completed by the end of 2017.

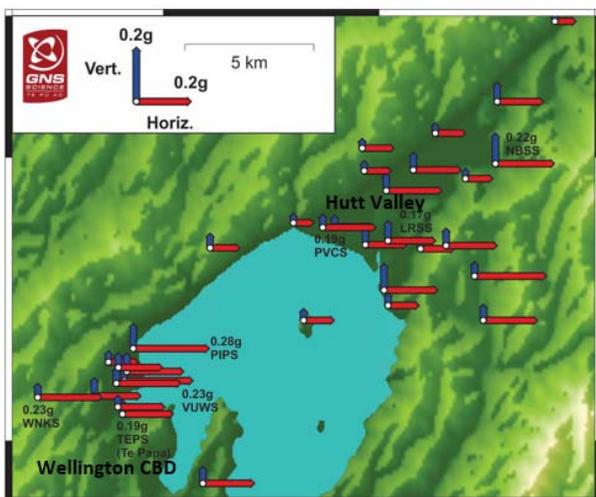
The local geological conditions could modify seismic waves, often referred to in literature as “soil effect”. The two most dominant factors are a) the stiffness or rock or soil near the surface, i.e. softer soils or rock will amplify ground motions, and b) the depth of any sediments above solid bedrock, i.e. shaking is amplified where sediments are thicker. A comparison of recorded PGAs across the Wellington region during the Kaikōura earthquake, refer Figure 6, shows higher PGAs on

softer grounds such as the Wellington CBD waterfront, which is largely reclaimed land, and the alluvial deposits in Hutt Valley, compared to the harder rock in the hills. Amplification of ground motions also occurs near the edge of sedimentary basins, termed basin-edge effects. Investigation into the cause of partial collapse of two floors at a building in Wellington during the Kaikōura earthquake concluded that amplification of ground motions primarily due to basin-edge effects were one of the determining factors (MBIE 2017).

Figure 6: Peak ground accelerations (PGAs) recorded around Wellington region, bottom of North Island. Larger PGAs recorded on softer materials, i.e. reclaimed land around CBD waterfront (bottom left) and alluvial materials of the Hutt Valley (northeast of harbour) compared to those founded on rock on north western fringe of the Hutt Valley. Original image reproduced from GeoNet 2016(b).
